SHORE EROSION STUDY

SHORELINE EROSION AND BLUFF STABILITY

ALONG LAKE MICHIGAN AND LAKE SUPERIOR

SHORELINES OF WISCONSIN

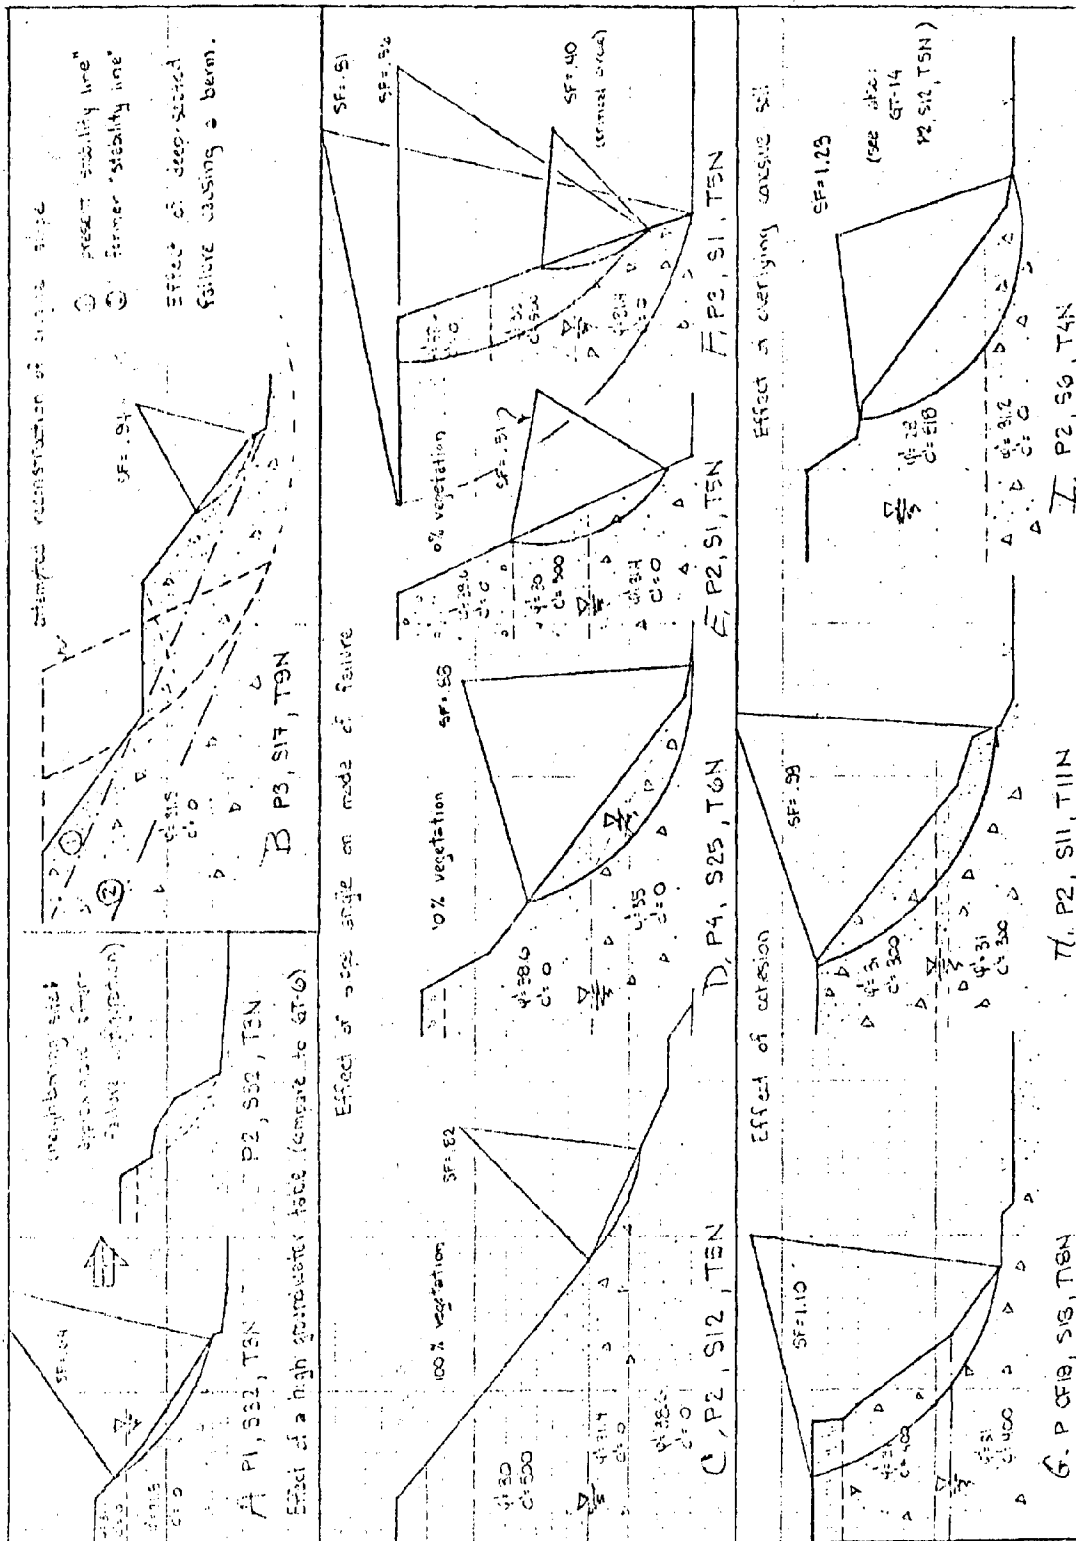
Figure 93. Profiles illustrating effects of groundwater, berm, vegetation, cohesion and overlying cohesive soil. See Fig. 94 for meaning of symbols.

(Fig. 93, Profiles C, D, E, & F) Increasing the slope angle decreases the Safety Factor of the critical circle, as can be seen in the above profiles each with similar stratigraphy, and cohesion equal to zero. The amount of vegetation also gives an indication of their relative stability, and decreases with an increasing slope angle.

As the slope angle increases, the critical circle criterion becomes of less interest than the largest unstable failure circle criterion. Profile D (Fig. 93) shows the limiting case where the critical circle is also the largest unstable circle; note that the slope angle is approximately equal to ϕ' . At this slope angle, also, the vegetation has decreased substantially, and the critical failure circle is much deeper than for slopes of a lesser angle.

In Profiles E & F (Fig. 93), the slope angle is so large, that the largest unsafe circle criterion controls, indicating a deep-seated failure mode for the bluff. This condition would suggest that failure, when it occurs, will progress very rapidly up the slope, causing a net failure of the entire slope.

A greater amount of cohesion of the soil making up a bluff will correspondingly increase the Safety Factor and the size of the critical failure circle. The critical circle becomes most important in the stability of the bluff, but Safety Factors may often exceed unity, as can be seen in Profile G (Fig. 93). Profiles A and H have approximately the same slope angles, and drained angles of internal friction, but their
